# Manhole Inspection Summary

Manhole # S39C2\_029MH

Insp Date: **12/11/07 8:14 AM**

**Location** Address: **4101 Orchard Ave**

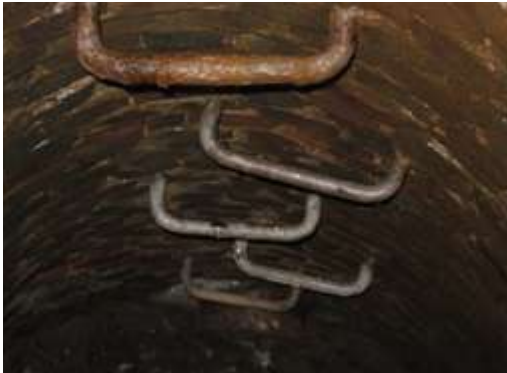
Count: **5** Missing: **0** ☒ **Corroded**

steps

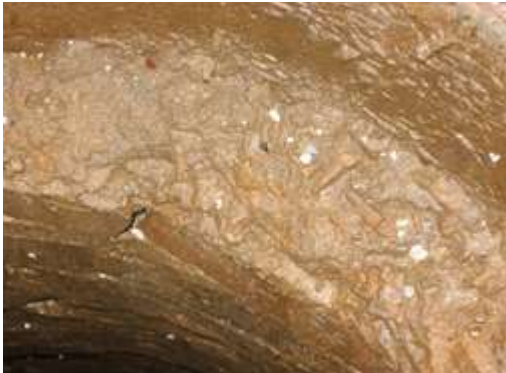
Defect 1

Offset: **2** (in.)

frame offset

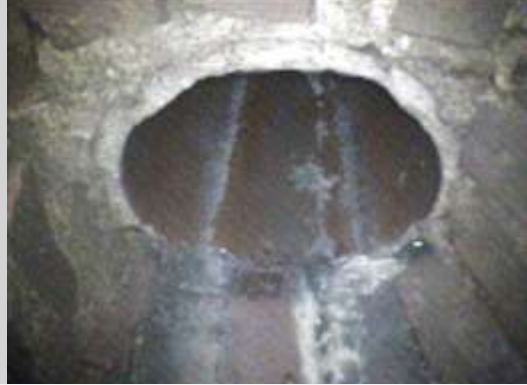
12 O'Clock Outflow

Pipe Height: **8.4** (in.) Rod and Bar (Angled)  
Pipe Material: **Clay** ☐ Pipe Lined  
Invert Depth: **10.56** (ft.) Flow Characteristics: **Fast**  
Deposits: ☒ None ☐ Mud ☐ Sludge ☐ Debris ☐ Grease  
Silt Depth: (in.) Deposits Extent:  
Infiltration: **None** Pipe Seal Cond: **Sound**

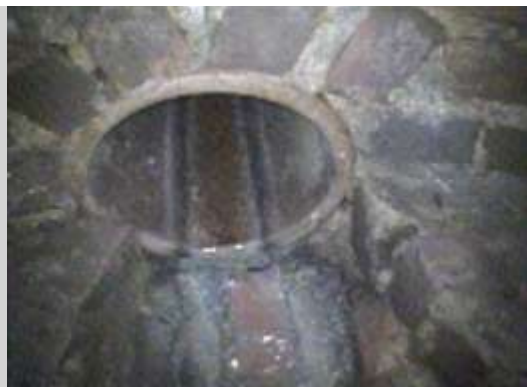
3 O'Clock Inflow

Pipe Height: **8.4** (in.) Rod and Bar (Angled)  
Pipe Material: **Clay** ☐ Pipe Lined  
Invert Depth: **10.20** (ft.) Flow Characteristics: **Fast**  
Deposits: ☐ None ☐ Mud ☐ Sludge ☒ **Debris** ☐ Grease  
Silt Depth: **3** (in.) Deposits Extent: **Light**  
Infiltration: **None** Pipe Seal Cond: **Sound**

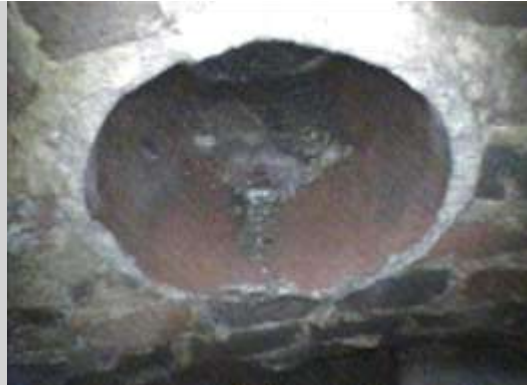
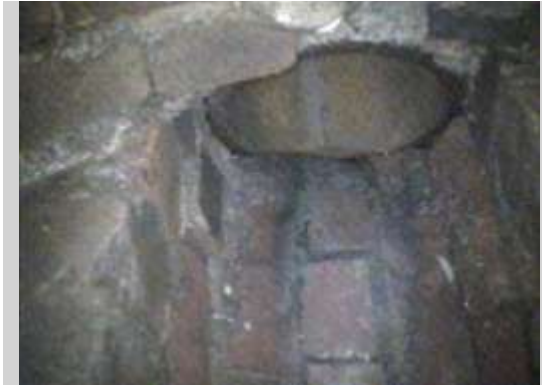
6 O'Clock Inflow

Pipe Height: **10.8** (in.) Rod and Bar (Angled)

Invert Depth: **8.86** (ft.) Flow Characteristics: **Slow**

Deposits: ☒ None ☐ Mud ☐ Sludge ☐ Debris ☐ Grease

Infiltration: **None** Pipe Seal Cond: **Sound**

Drop: **Outside** Rod and Bar  
Angled: **Yes** Reading: **9.00** (ft.)  
Inv Depth: **10.00** (ft.)  
Drop Condition: **Open**

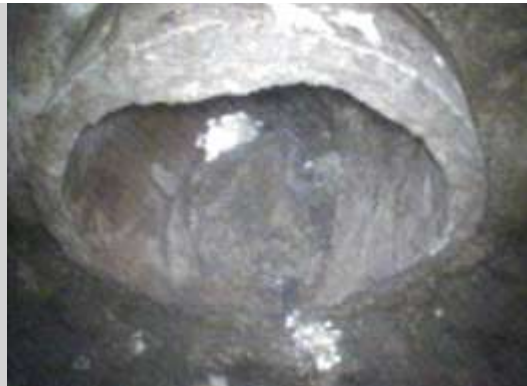
9 O'Clock Inflow

Pipe Height: **8.4** (in.) Rod and Bar (Angled)

Invert Depth: **9.82** (ft.) Flow Characteristics: **None**

Deposits: ☒ None ☐ Mud ☐ Sludge ☐ Debris ☐ Grease

Infiltration: **None** Pipe Seal Cond: **Sound**
